**Construction Plant-hire Association
Tower Crane Interest Group**

TIN 023

**Luffing Jib Tower Cranes -
Information and Actions for Owners/Suppliers**

**Report on technical aspects of HSE's
investigation into the collapse of a luffing tower
crane at a Liverpool construction site on 15th
January 2007**

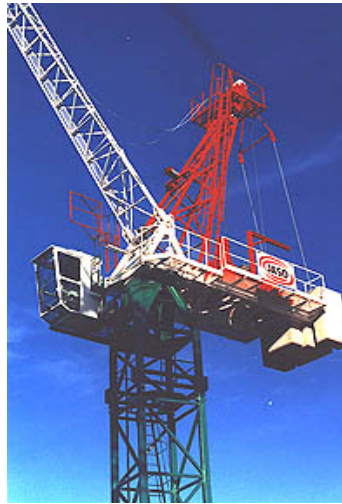
Photograph 1: Luffing jib tower crane similar to that involved in the accident

5. The crane was a luffing tower crane (see Photograph 1, Appendix 1) consisting of a slewing unit, operator’s cab, counterweights, luffing hoist and winch drums and jib attached via a slewing ring to the top of a tower comprised of a number of sections. The tower sections were pinned together and secured to a specially constructed foundation pad (see Illustration 1, Appendix 1).

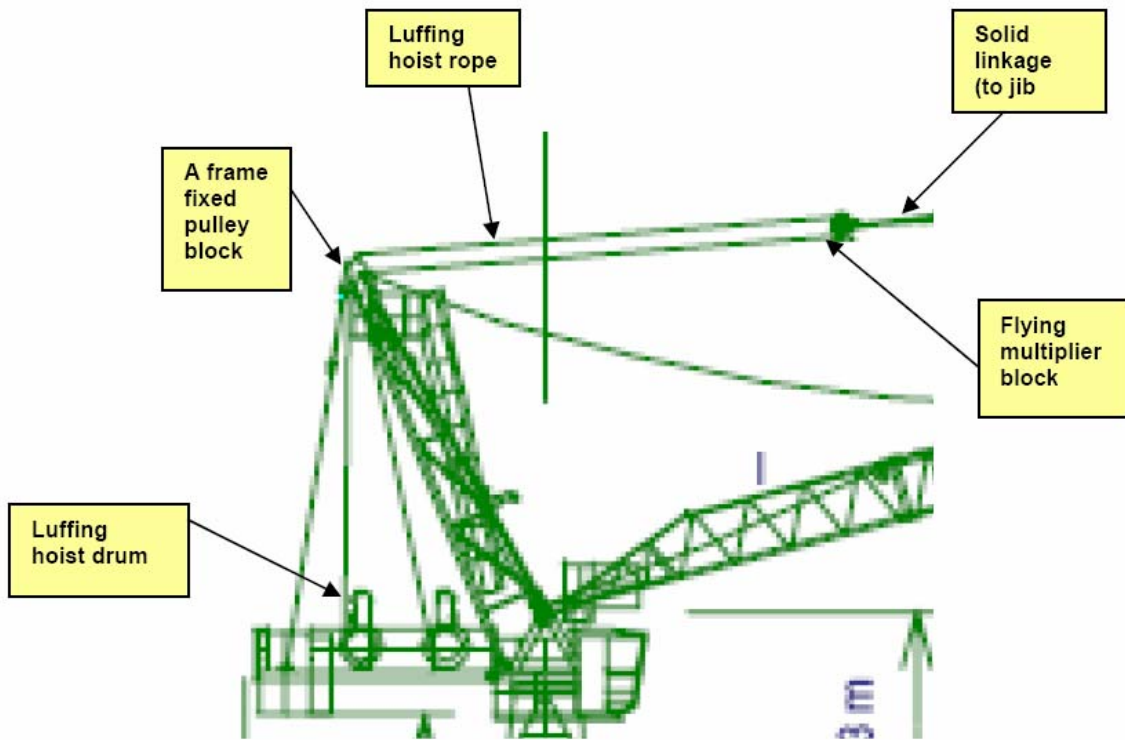
Illustration 2: Schematic of luffing hoist configuration

8. The luffing rope was reeved around a fixed pulley block which was secured to the A frame and a flying multiplier block which was connected in turn to the end of the jib via a solid linkage (see Illustration 2, Appendix 1).

- 37. Witness marks on the luffing limit buffers indicated that they had been partially compressed.
- 38. Several pulleys on the luffing hoist fixed block and the flying multiplier block had failed and witness marks on remaining pulleys indicated that the luffing hoist rope had come off the pulleys.

- 39. Examination of the fixed pulley block showed it was fitted with a single retaining bar designed to prevent the ropes coming off the pulleys whereas the flying pulley block was fitted with 4 such retaining bars.

- 52. *The design of the protective device on the fixed block – the single bar – was not adequate to prevent the rope from coming off the pulleys and jump into the gaps between them.*

- 53. *As the wind gust subsided, the jib, under gravity, restored tension on the luffing rope causing it to jam between the pulleys and the casings of the blocks. This resulted in the jib hanging in a position near to minimum radius.*

- 65. *From our investigation, it would appear that better protective devices to prevent luffing ropes from coming off their pulleys would significantly reduce the potential for further events, particularly where wind and operating conditions provide potential for slack rope conditions to arise. And alternative or additional precautions may also be required.*
