SAFETY INFORMATION

ANEMOMETER MUNRO TYPE 2

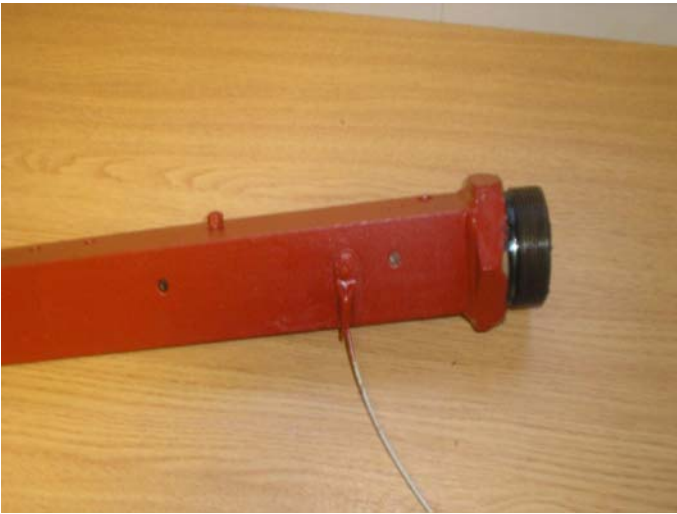
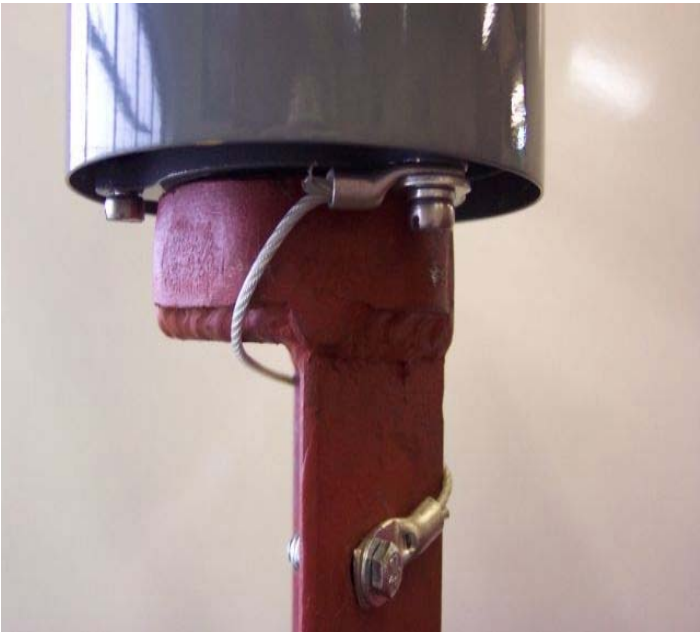
The following photographs show the new bracket and locking strap fitted to all Munro MK2 anemometers;

1. All anemometers to be immediately inspected to ensure that they are securely attached to angle brackets.
2. Mounting system to be replaced with a bracket which allows for a visible inspection to be undertaken to ensure that the anemometer is fully bottomed out.
3. A locking system to be fitted to all anemometers to prevent rotation on the threaded mounting bracket.
