**Construction Plant-hire Association
Tower Crane Interest Group**

TIN 023

**Luffing Jib Tower Cranes -
Information and Actions for Owners/Suppliers**

**Report on technical aspects of HSE's
investigation into the collapse of a luffing tower
crane at a Liverpool construction site on 15th
January 2007**

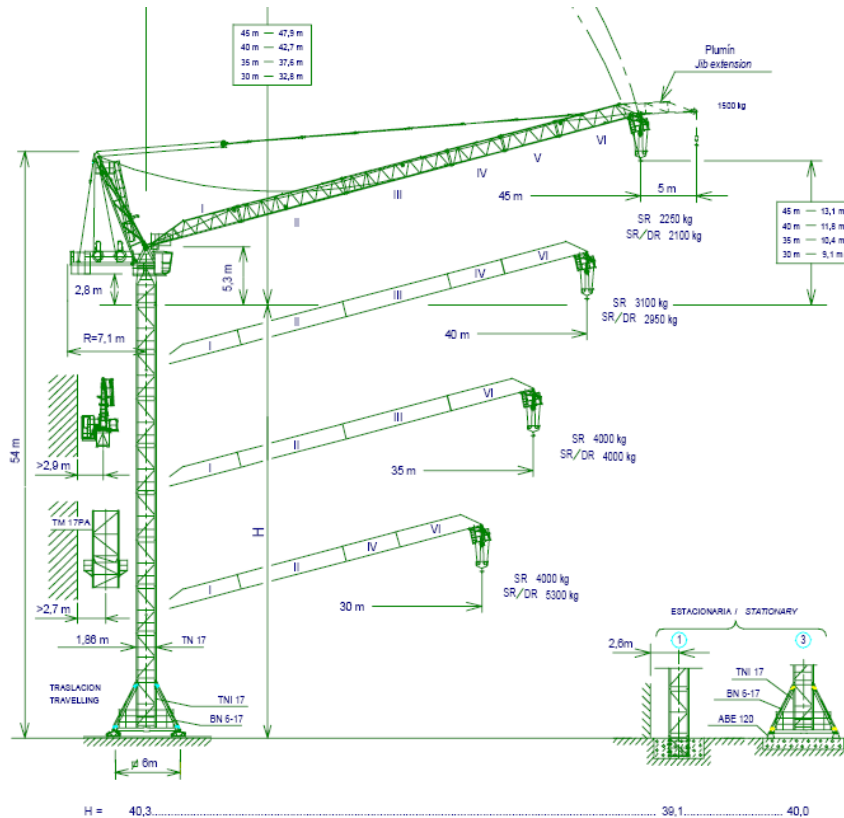
Illustration 1: JASO138PA Scale drawing

5. The crane was a luffing tower crane (see Photograph 1, Appendix 1) consisting of a slewing unit, operator’s cab, counterweights, luffing hoist and winch drums and jib attached via a slewing ring to the top of a tower comprised of a number of sections. The tower sections were pinned together and secured to a specially constructed foundation pad (see Illustration 1, Appendix 1).
