Safety Bulletin (Gas) SB/10552

MacQuarie Company – Fatality Alert

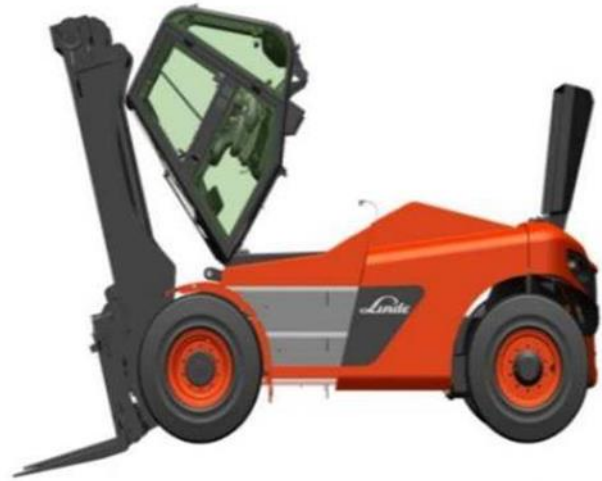
- The following day a mechanic was sent to fit a replacement starter motor. The forklift truck had a forward tilting cab (see photograph). The mechanic used the electric hydraulic pump to tilt the cab. The forklift 'mast' was raked backwards, and it would not allow the cab to 'tilt' fully forward and engage the cab securing mechanism. This meant that the cab was only held in the raised position due to the hydraulic system.

This photograph shows the correct alignment,

- mast raked forward,
- cab tilted fully forward

- This tragic incident occurred in another MacQuarie portfolio company and, although an investigation is underway, the immediate facts are worth sharing to prevent similar incident happening.
- Although this particular incident involved maintenance of a fork lift truck, the key message is the importance of safety and protection devices on plant, vehicles and equipment.
- When circumstances change or it is not possible to proceed with work as planned or according to procedure:
 - STOP the activity, making safe any ongoing processes
 - ASSESS the situation and summon additional support if required
 - PLAN the controls required to continue the operation safely, with appropriate authorisation

- Cadent have 39 Fork Lift trucks
- Contact is underway with BT Fleet to understand how many of them have tilt cabs and what their safety procedure is when the cab is required to be tilted.
- 5 are with Operations and the remaining 34 are with DHL but serviced through the BT Fleet contract
